THE TROUBLED TRUSS

A truss for holding traffic signs and spanning a heavily traveled Freeway was knocked down by a dump truck being used in repair work. The broken truss was removed from the highway as soon as possible. The question now is a matter of what should be done in terms of replacement or repair.

© 1977 by C. O. Smith, College of Engineering and Technology, University of Nebraska, Omaha, Nebraska.

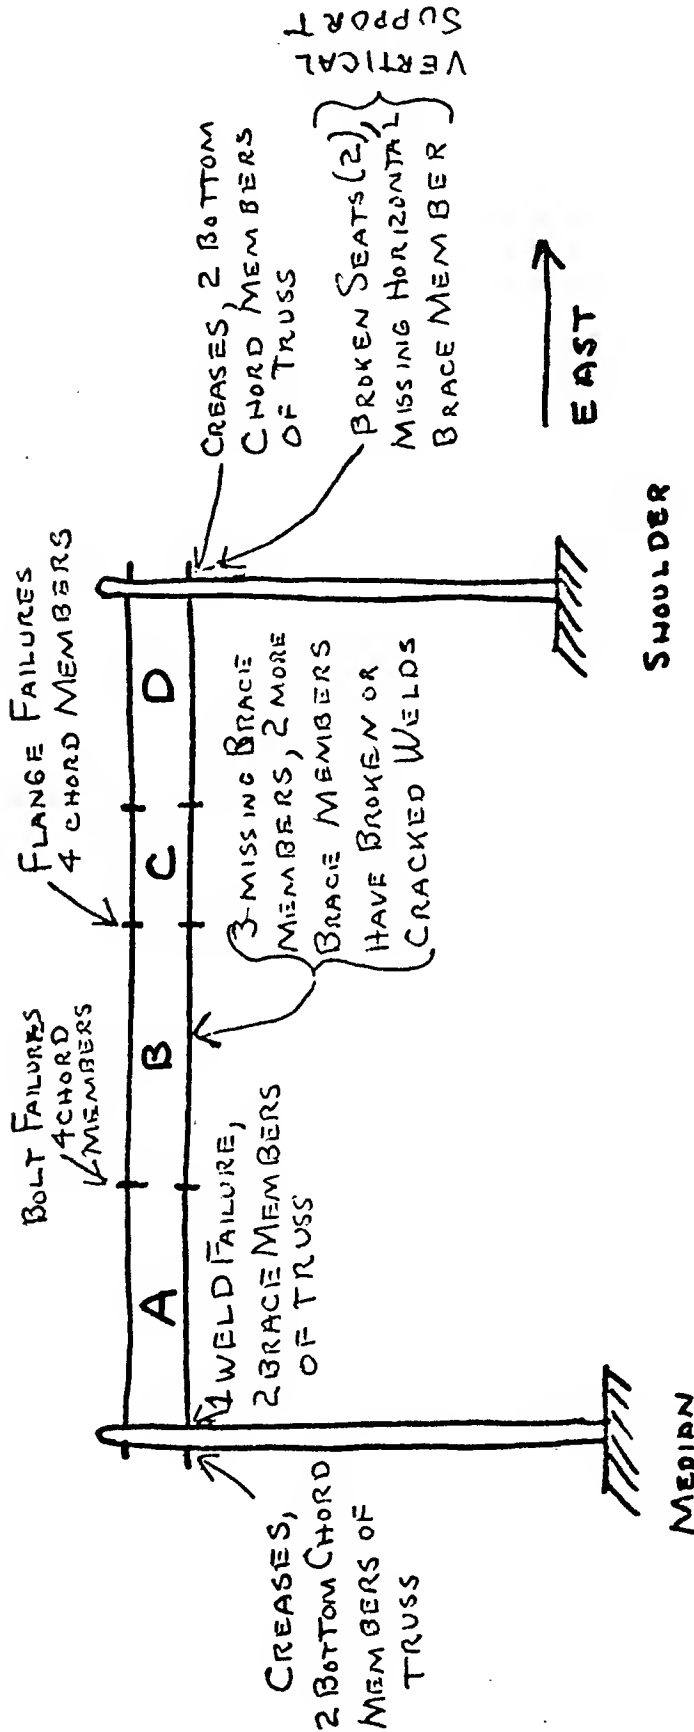
EXHIBIT 2 - TRUSS & VERTICAL SUPPORTS AT LODGE & DAVISON FREEWAYS, DETROIT, SHOWING MAJOR ITEMS OF DAMAGE (SCHEMATIC)

Section A has creases in the bottom chord members as noted (Exhibit 2). Two brace members are separated from the chord member at the end (vertical support end). This separation is through the weld between these two members and the chord. There is no other immediately obvious damage.

Section B appears to be the section which was hit by the truck. There is a dent on one side of one of the chord members, in about the middle of section B. Three brace (web) members are missing and two other web members have broken or cracked welds (Exhibits 7 and 8). These are in the immediate vicinity of the apparent impact region. The junction between sections A and B failed by failure of the bolts holding the flanges together.

The junction between sections B and C failed by separation of flanges from chord members. The chord member is a tube which has the end inserted into the flange with the flange and chord then welded together on both sides of the flange. Failure of the junction between sections B and C thus involved failure of both welds between chord and flange of all four chord members of the truss (Exhibits 6 and 9). Other than failure at the flanges, there is no other immediately obvious damage to section C.

The junction between sections C and D failed by failure of the bolts holding the flanges together. Other than the creases in the outboard ends of the bottom chord members of section D, there is no immediately obvious damage. Portions of some bolts are shown in Exhibit 10.

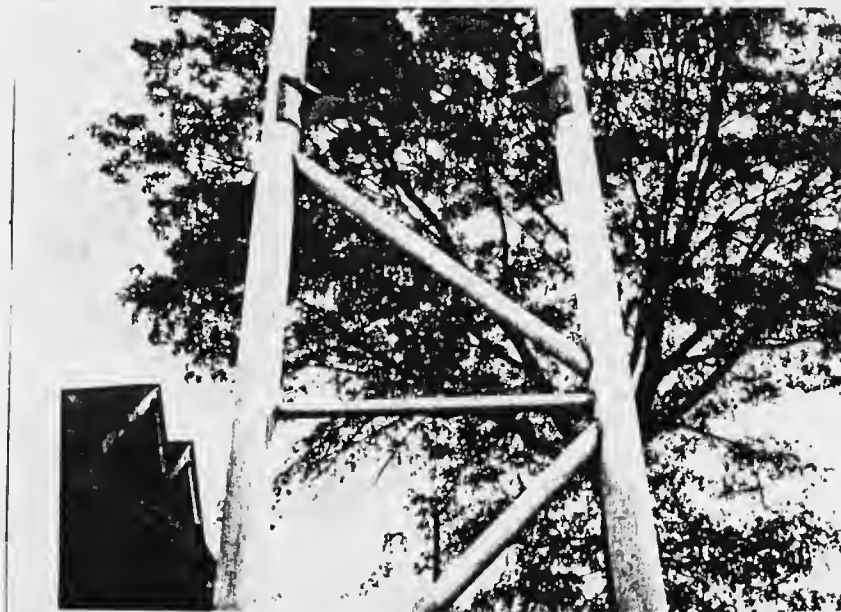
The vertical support columns and seats at the west end (median end) of the truss are undamaged. The vertical support columns at the east end (shoulder end) have both seats broken and a horizontal brace member immediately below the seats is missing (Exhibit 3). No other damage is immediately obvious.

Exhibit 3 Vertical support at east end of structure showing broken support seats and horizontal bar missing just below the support seats.

In the case of the vertical support column (east end), the broken segments of the seats can be removed and replacements welded in place. A replacement member for the missing horizontal member can be welded in position.

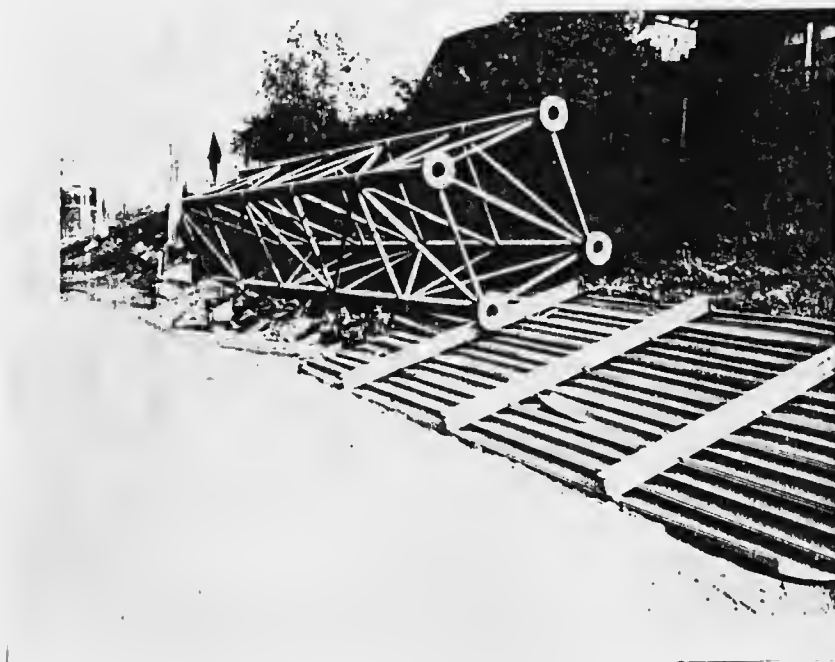
The segments of the sign itself which were at the Wayne Salvage Yard appear to be essentially undamaged and presumably can be placed back in normal service with no repairs. One segment of the sign was located at the scene of the accident (Exhibit 4). This segment sustained some damage. The sign was made from a series of extrusions which were joined together. There were some small bends in some of the extruded sections. Two of the extruded sections were partially separated at one end through failure of a few mechanical fasteners. One extrusion was punctured and a small portion along one side of the puncture was bent out of position (Exhibit 4).

Exhibit 4 West end of truss (Section A, Exhibit 2) with damaged portion of sign.

It can be argued that the segment of the sign which is damaged should be replaced. It is my opinion that, while this is possible, it would also be possible to straighten out the dents and bends and to put new mechanical fasteners between adjoining extruded segments as required. The punctured and bent segment can be flattened back into position with a backing strip fastened on the back of the sign.

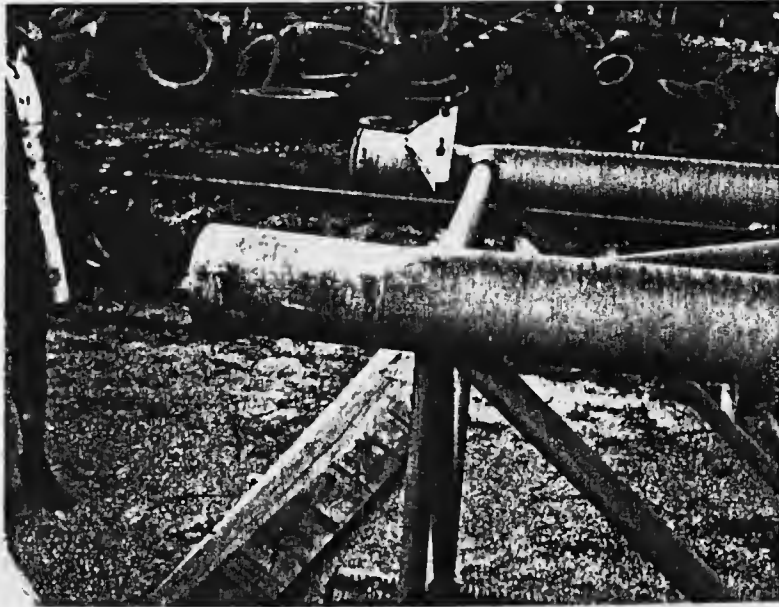
The outboard ends of sections A and D have creases across two of the chord members in each section. A segment of the broken seat from the east column is still attached to the chord member by the U-bolt (Exhibit 5). It appears that as the box truss fell from its normal operating position, the loading was such as to cause these creases across the bottom chord members.

Exhibit 5 East end of Section D (Exhibit 2) showing broken portion of support seat still attached by a U-bolt.

It is my opinion that the presence of the creases at the support positions at each end of the bottom chord members of the box truss will have no significant effect on the strength of the box truss and thus will have no adverse effect if the box truss is repaired as suggested above and replaced in position, with the creases still present.

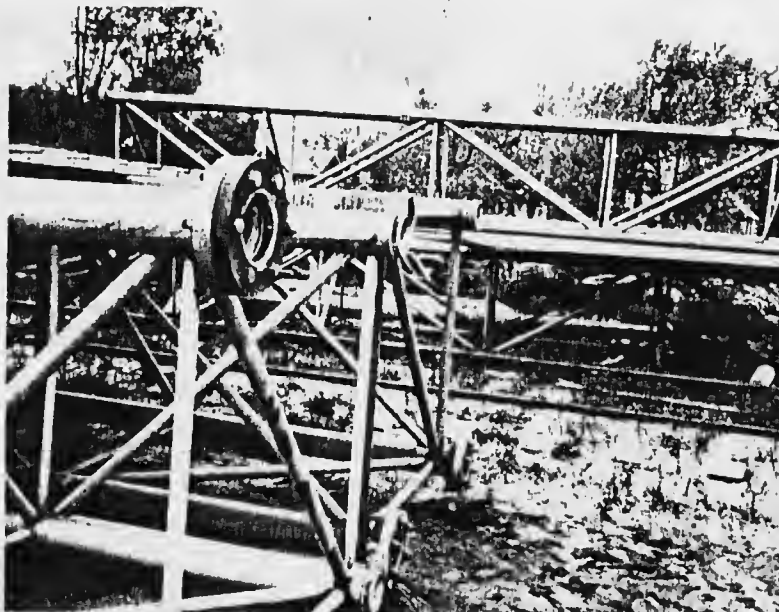
Exhibit 6 Mating ends of Sections B and C (Exhibit 2) showing failure of junctions between chord member and flanges.

It is my opinion that the sign supports involved can be reused after some repair. All failures through welds can be repaired by rewelding where members are still present. Some replacement members will be needed. These can be obtained and welded into the appropriate positions. The weld failures at flanges can be repaired either by rewelding of the failed flanges or by welding replacement flanges in the required locations. Rewelding will have no detrimental effects on the structure. It has been shown (*) that rewelding of 6061-T6 with filler alloy 5356 (and no subsequent thermal treatment) has no significant affect on tensile

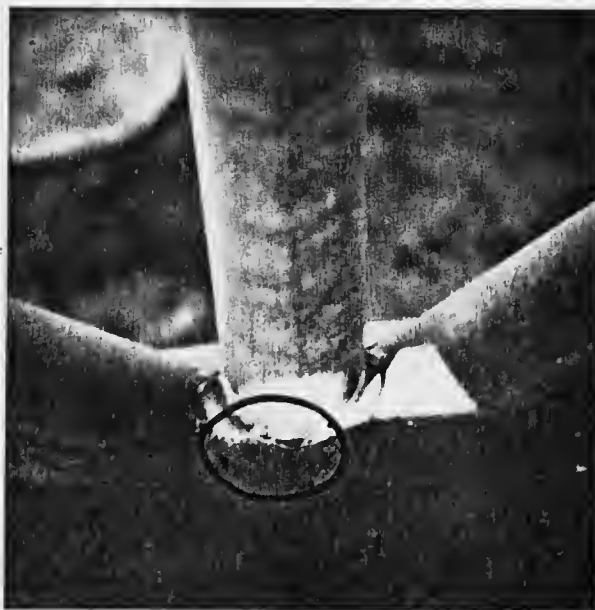
Exhibit 8 Section of box truss showing a crack in the weld between main chord member and web member. This is the other end of the bracing member shown in Exhibit 7.

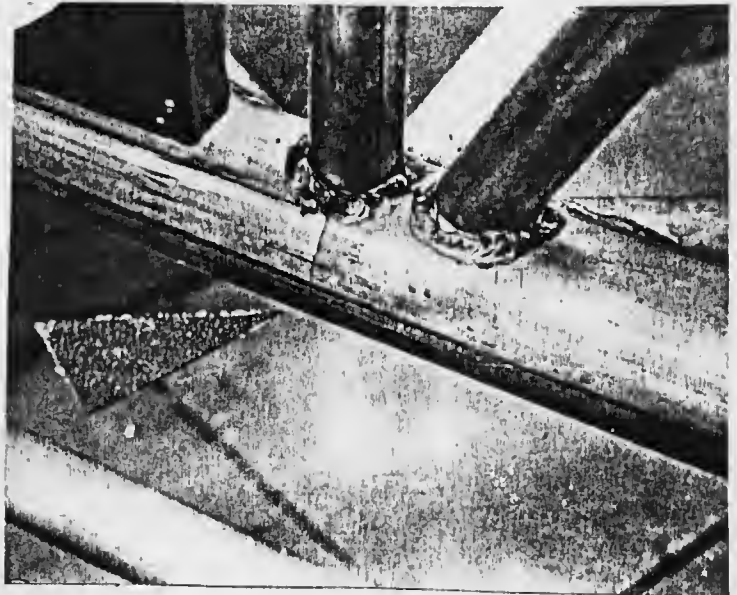
Consider a similar truss but erected at a different time in a different place. In this situation, the truss had been in service for some months when men doing some work on the truss noted a crack as shown in the left hand photograph. Further examination revealed the cracks noted in the right hand photograph. This obviously caused considerable concern. A careful examination of the rest of the truss and the general circumstances gave no indication of any specific reason for the cracks.

After extensive "soul searching" and/or "head scratching" following careful examination of the truss and the circumstances, observers were sent out to watch the truss. This sounds somewhat like a move of desperation but it was believed that there might be something which had been overlooked. As it developed, after some period, an observer heard the truss almost literally "singing in the wind." The highway at that point was in a valley and the wind channeled through. It was concluded that the truss was in resonance (or close to it) and thus failure was fatigue from relatively low-cycle, high amplitude loading. The truss was redesigned for a much higher natural frequency. The redesigned truss functioned without difficulty.
